## Mavuzi and Chicamba hydroelectric power plants rehabilitation

Complete rehabilitation of Mavuzi and Chicamba HPP's for Electricidade de Mozambique (EDM), EPC contract under FIDIC silver book

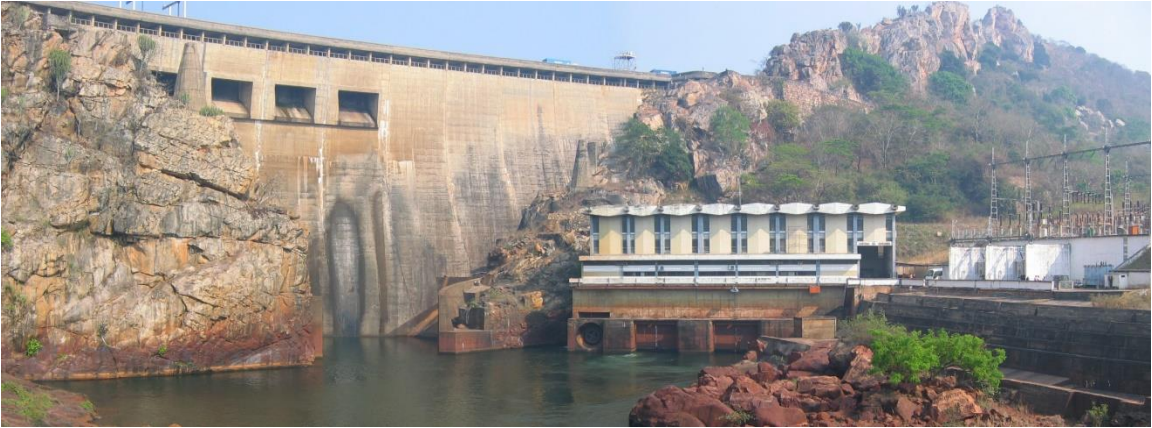
### CHICAMBA

- Double-arch and double-curvature dam
- 2 penstocks: **Length : 70 lm, diameter: 3500 mm**
- Power plant with 2 Francis unit, 24 MW each
- 4 spillway gates: **Dimensions : 9,600 x 2,540 m**
- 5 spillway stop logs: **Dimensions : 9,720 x 2,000 m**
- 2 draft tube stop logs: **Dimensions : 6,935 x 1,850 m**
- 2 intake gates: **Dimensions : 6,655 x 3,910 m**
- 2 intake trash rakes

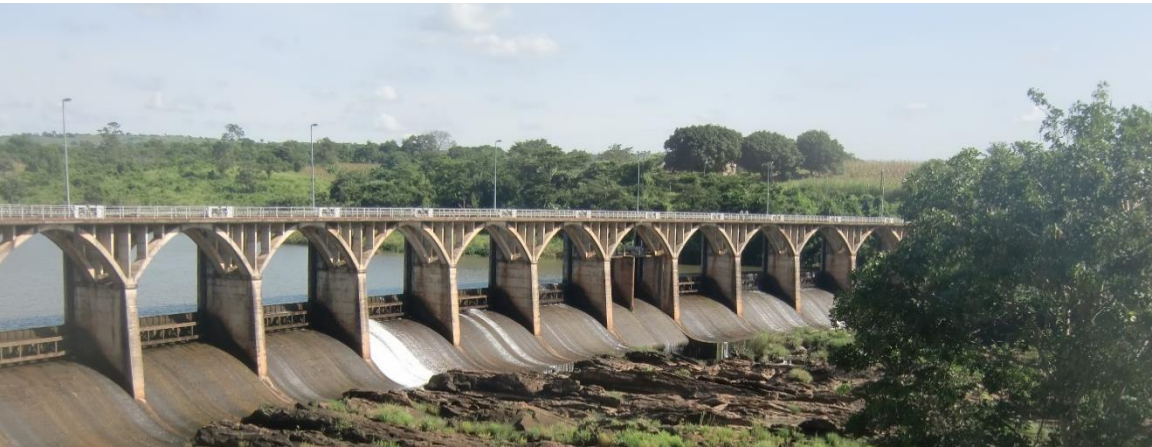
### MAVUZI

- Arch bridge dam
- 12 spillway gates: **Dimensions : 16,260 x 2,657 m**
- 3 bottom outlet : **Dimensions : 6,280 x 1,995 m**
- 2 intake gates: **Dimensions : 4,205 x 3,890 m**
- 5 desanding valves
- 1 tunnel intake's channel : **Length : 2000 m**
- 3 penstocks : **Length : 600 ml , Diameters 1500 mm and 1850 mm**
- Power plant with 5 Francis units, 2 of 5 MW and 3 of 13.3 MW

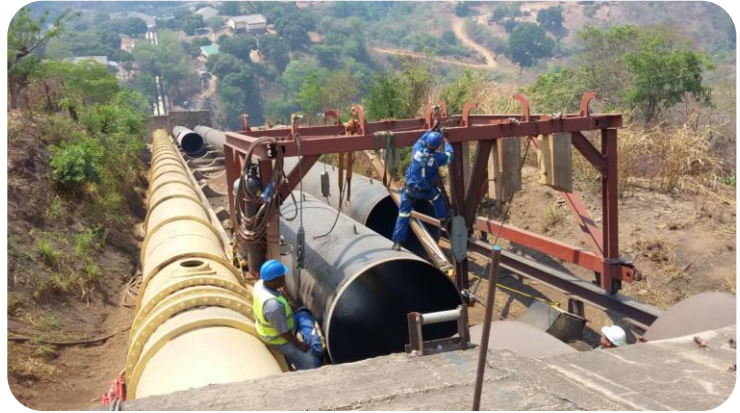
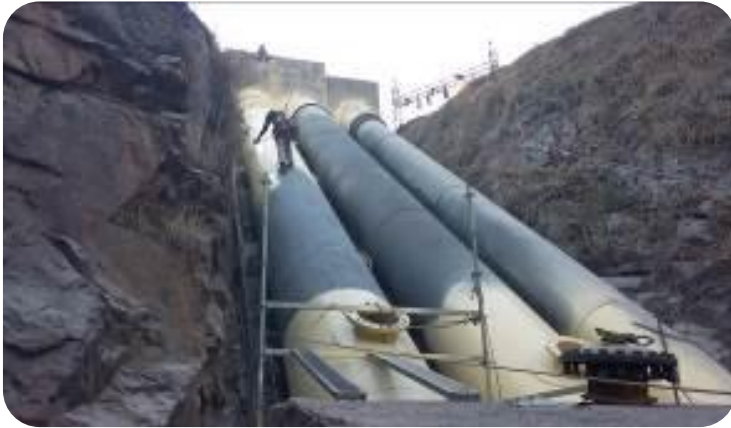
Penstock replacement

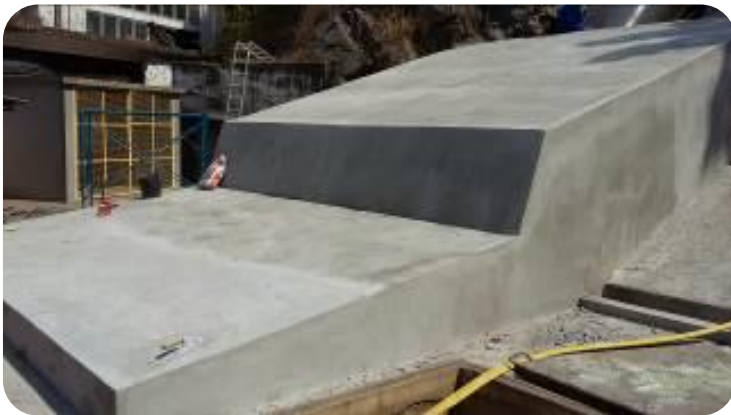
Inside and outside coating

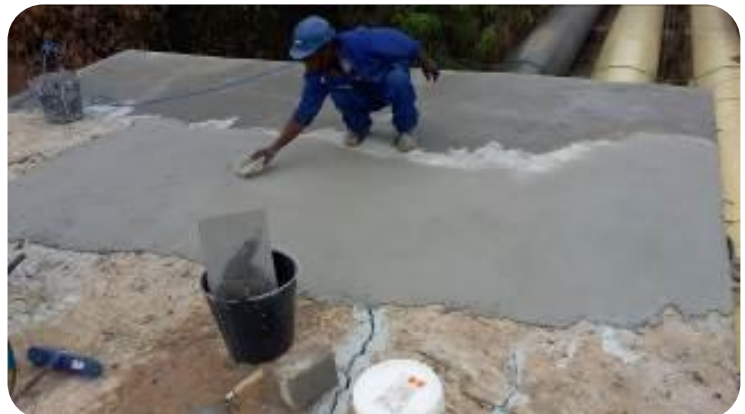
Foundation refurbishment and prestressed wire replacement

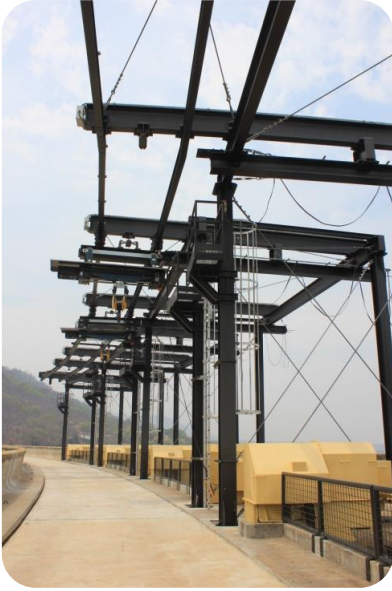
**Step 1 : Gantry crane manufacturing and installation to remove gates from embedded parts**

The use of a mobile crane was not possible due to the dam crown capacity

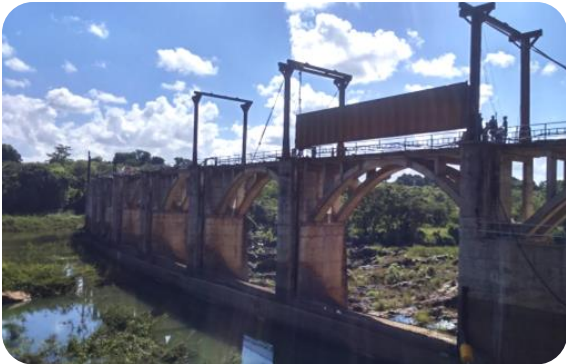
*Spillway gates removal with temporary gantry crane*

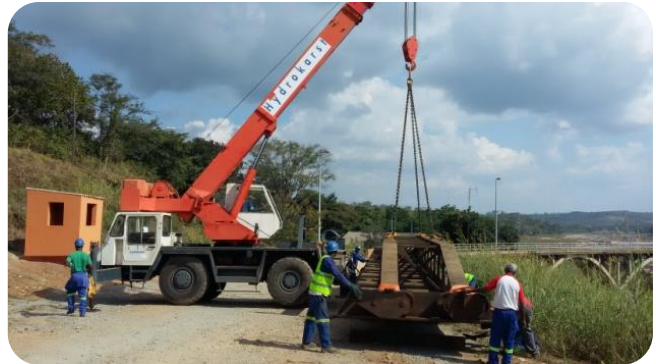
*On site gates storage*

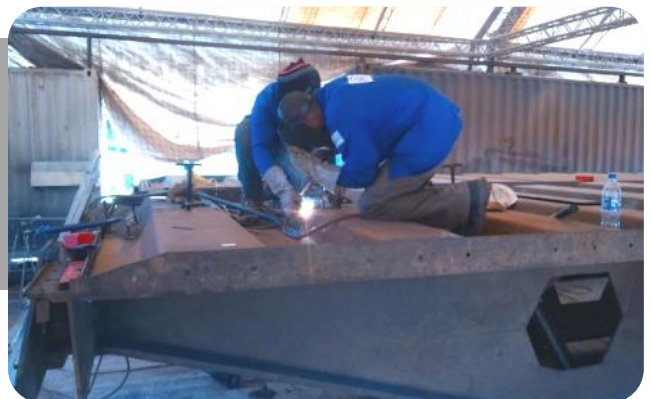
**Step 3: Gates rehabilitation, due to extrem corrosion, majors parts of the gates had to be replaced**

*Welding on gate*

- Pre-blasting
- Thickness measurement
- Streghtening parts replacement
- NDT testing
- Blasting
- Coating
- Seals replacement

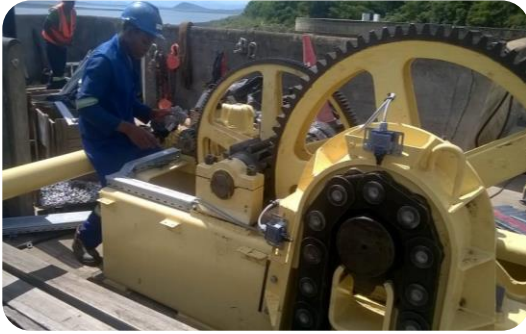
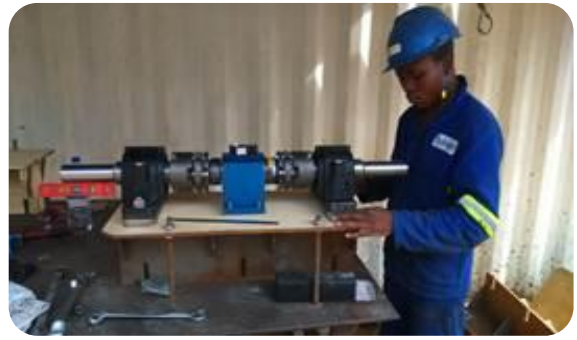
*Motorization shafts and bearings assembling*

- Cleaning
- Disorder inspection
- Blasting and coating
- Cells, brakes and motorization parts replacement
- On site re-assembling

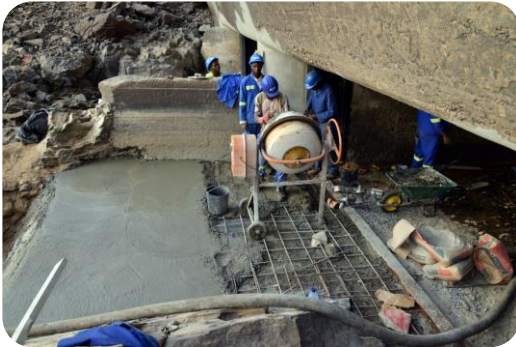
*Bottom outlet embedded parts refurbishment on Mavuzi*

- Inspection
- Civil works refurbishment
- Blasting, coating
- Thickness measurement of coating

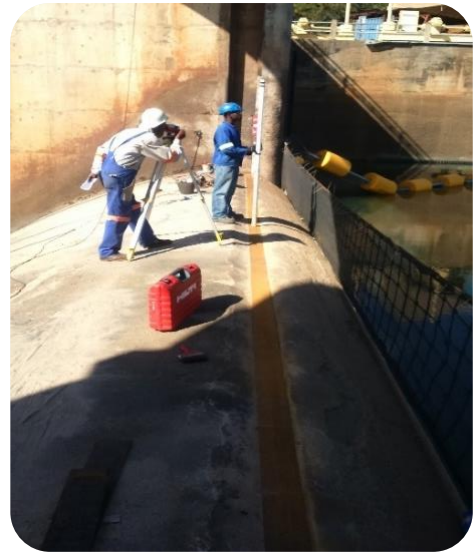
*Installation control of spillway embedded parts*

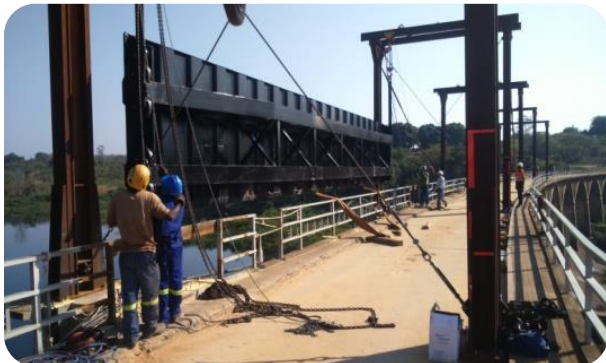
*Refurbished gate installation*

Once the refurbishment of gates and motorization is completed and after the connection of new electric boxes, we proceed to the installation of equipment.

Gate operation and sealing is controlled during commissioning

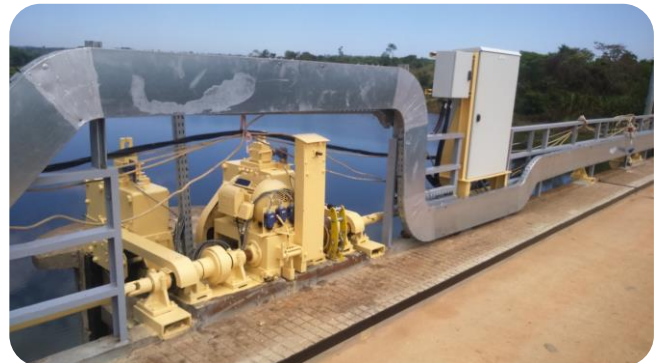
*Refurbished motorization and electric box*

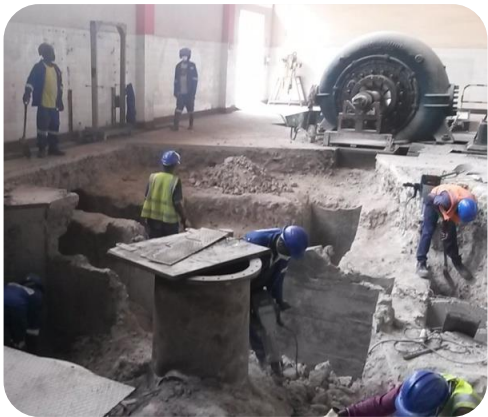
*Apron demolition*

Within the frame of unit 1 and 2 replacement, Hydrokarst carried out civil works which consisted in demolition of old concrete structure around units et rebuild foundation structure to install now spiral casing and generators

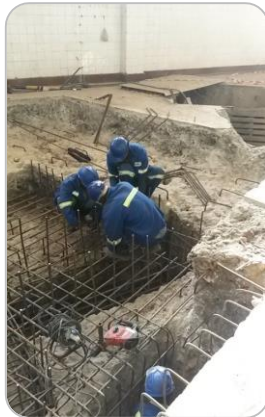
*Reinforcement installation*

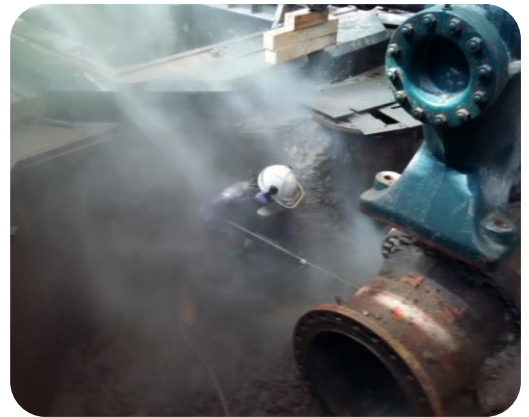
*Hydrodemolition*

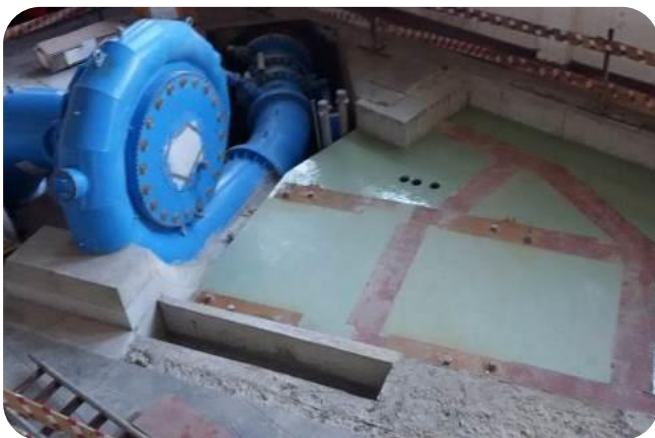
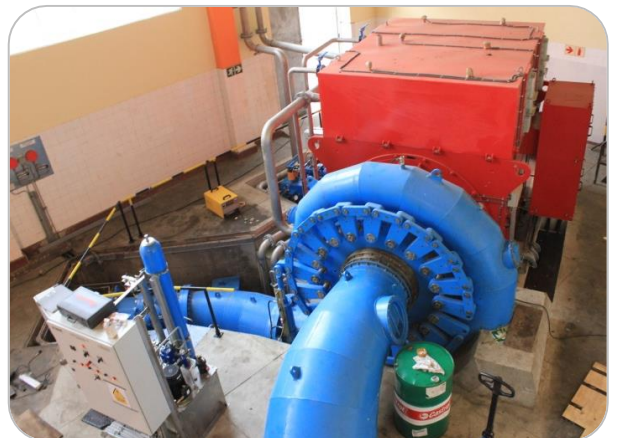
*Views of the new foundation*

The efforts to consider for the design were 10.027 kN vertical and 1 200 kN horizontal at the beginning of spiral casing.

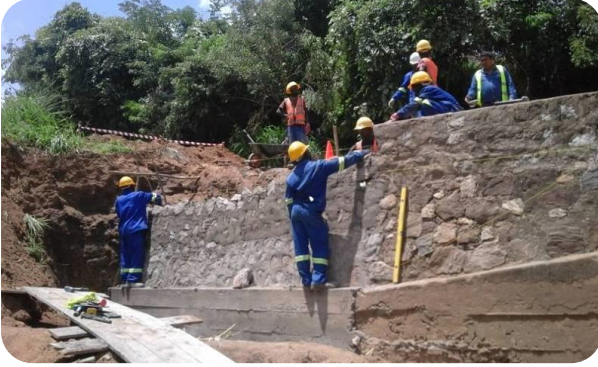
*Culverts rehabilitation*

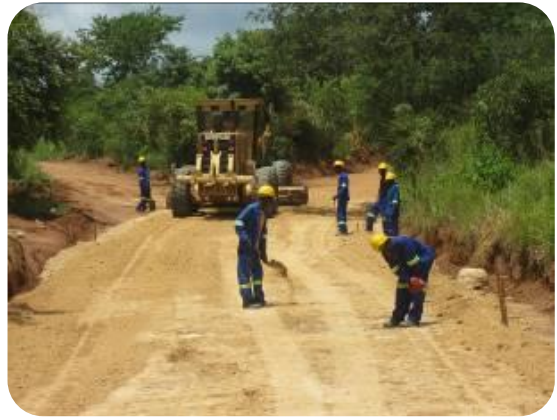
*Road sub-layer levelling*

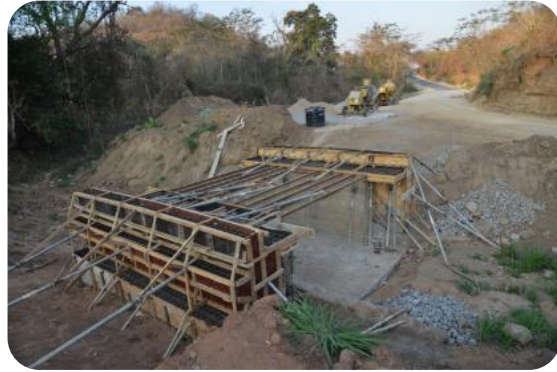
*Bridge under construction*

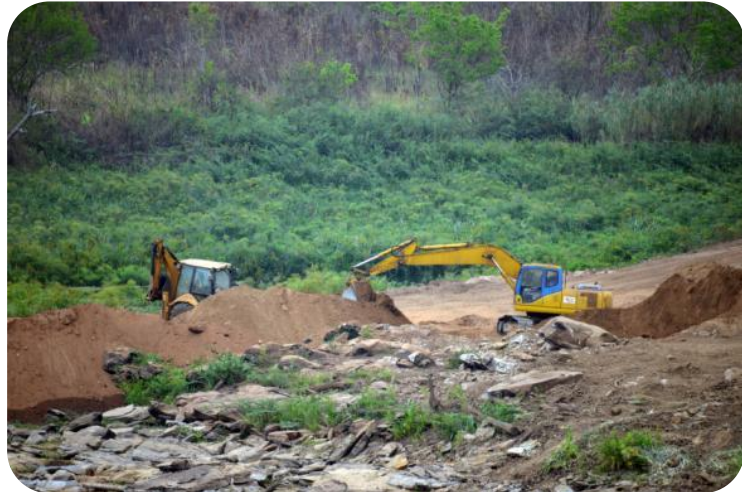
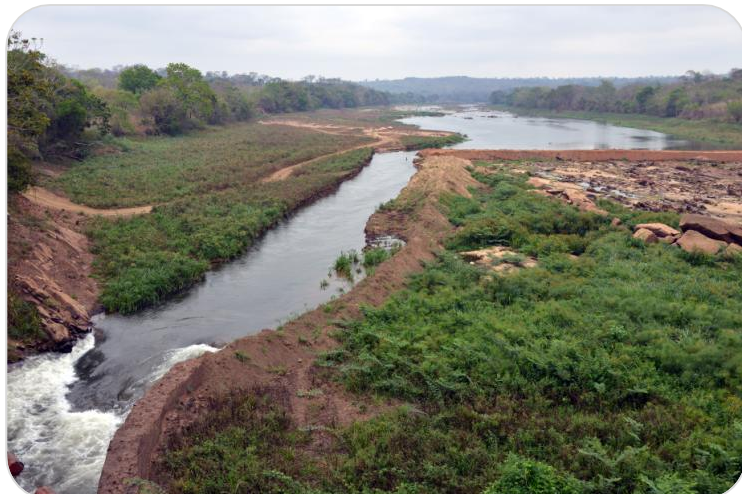
In order to dry the bottom outlets 2 and 3 area, Hydrokarst build an earth embankment to control the river flow during the rehabilitation of Mavuzi's gates

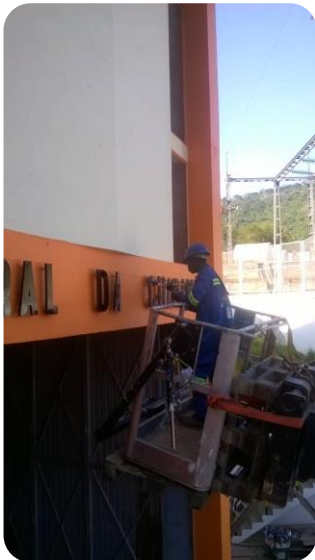
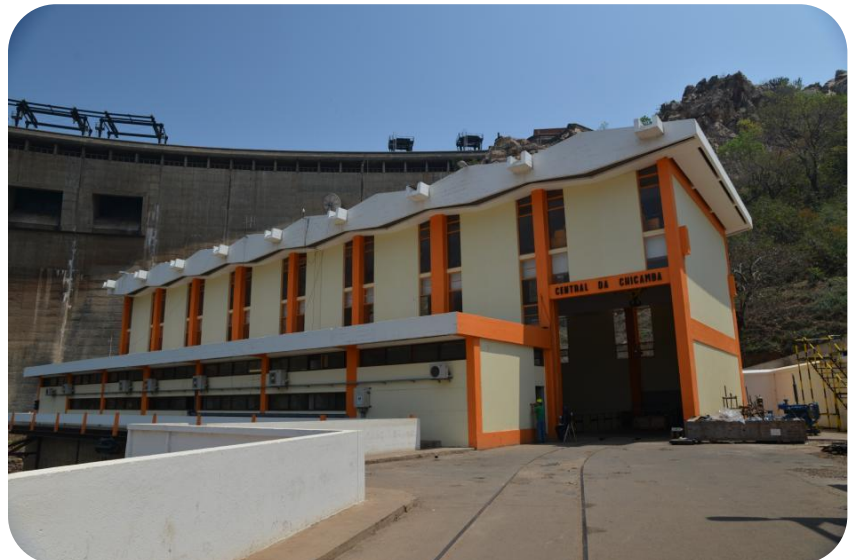
*Painting on Chicamba facade*

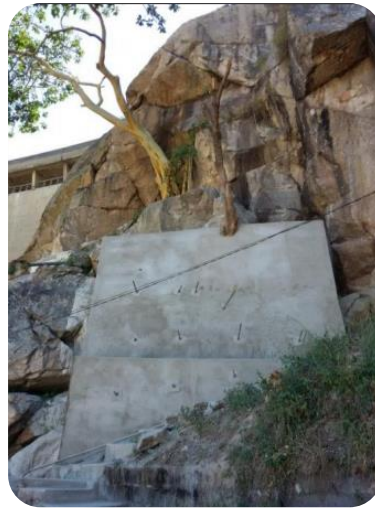
### Rock fall protection around both HPP's
